Underwater automated system for grid and structure inspection

Underwater crack inspection

Case study: Hydro power plant in Geneva

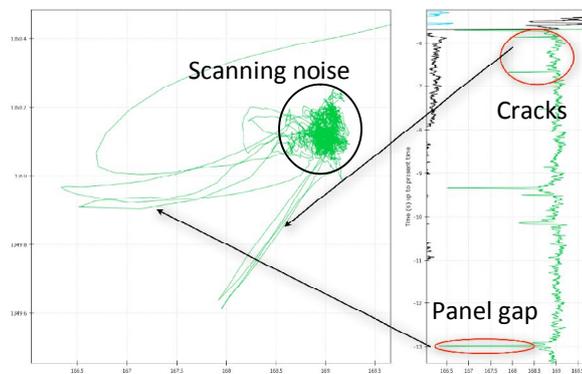
The coils were driven at 150 kHz and the voltage measured in absolute configuration was demodulated at the interrogating frequency. A map of 44 bars is presented in Figure 5 with the bar number as horizontal axis and the position in m as vertical axis. The colour code is the amplitude of the component of the demodulated signal projected along the panel gap direction. This has been determined from a calibration sample produced from the same carbon steel as that of the grid. In addition, the direction of the cracks in the impedance plane has been determined from WEDM notches performed on the same sample.

Figure 4: Impedance plane (left) and time series of the horizontal component of one probe passing over the gap between the panel (bottom) and 2 defects (top). Note the remarkable low scanning noise compared to the crack indications.

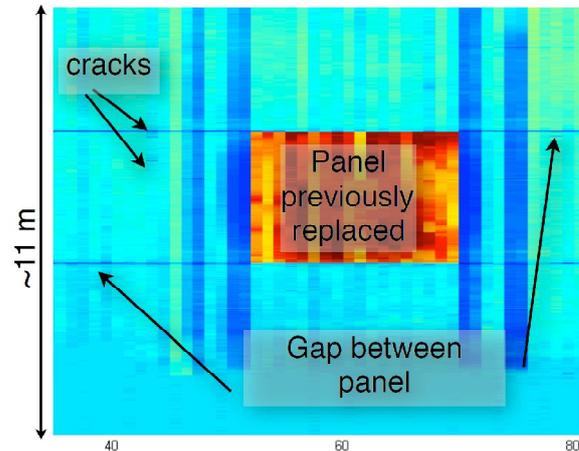
Identification of indications has been performed using a standard NDT EC methodology based on the selection of data corresponding to trajectories deviating from the scanning noise and from the expected panel gap or edge trajectories.

Figure 5: C-scan of a about 11x4m² part of the grid with the horizontal component of the impedance in color code. The vertical axis is the vertical length of the bars and the horizontal axis the bar number. The cracks of Figure 4 appear as 2 short dark blue lines ("cracks") located on one bar while the gap between the panels is seen as dark blue lines crossing horizontally the grid. These features show distinct phase response. A panel, previously replaced, appears as a different color because different materials have been used.

Panels showing the "cracks" indications presented in the previous section have been taken out of the grid and replaced with new ones. Although the cracks were not visible on the raw panels, grinding of the rust demonstrated the presence of long cracks, extending as expected, from the weld to the bar edge. An example of such a crack is given in Figure 6.

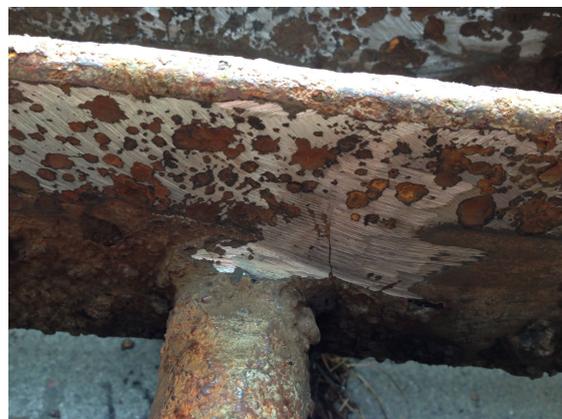
(rectangular section) at the location where the horizontal bars (circular section) have been welded (see Figure 4). Cyclic displacement of the bars caused by the flow resulted in fatigue crack propagation from the weld to the bar edge and, at few occasions, to the failure of the vertical bars. Project specification therefore consisted in a systematic inspection of the 7'300 welded intersections, with a crack detection threshold of 2 cm. Based on the crack distribution provided by the inspection, the owner could prioritise the replacement of the most damaged panels and spread its investment over a longer period of time while keeping the risk of failure low. Additionally, the inspection should have no impact on the operation of the plant, which together with the volume of the inspected tasks, excluded the use of a diver.

Figure 6: Grinded intersection of a panel showing a crack extending from the weld to the bar surface.
