Underwater automated system for grid and structure inspection

Underwater crack inspection

Case study: Hydro power plant in Geneva

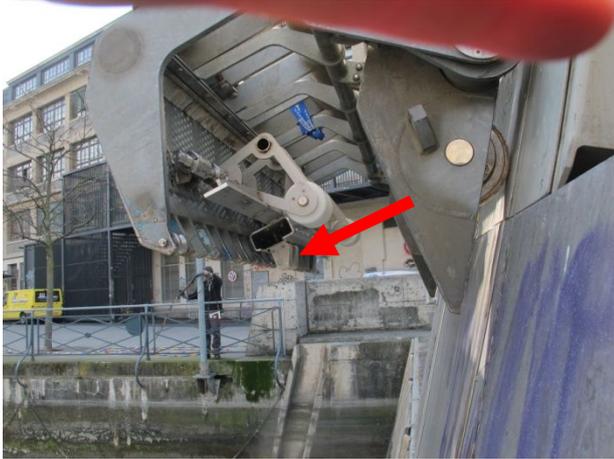
Figure 3: Bucket of the crane used to clean the grid with the inspection system attached inside it. The red arrow points to one of the 8 "U" shaped EC sensors. At the bottom of the grid, at about 15m underwater, the bucket is closed and the EC sensors are positioned on the bar to be inspected. Inspection is performed while the bucket is pulled up.
